# Manhole Inspection Summary

Manhole # S15II1038MH

Insp Date: **6/15/07 10:55 AM**

**Location** Address: **2400 COLD SRPING LN** Cross Street: **GREENSPRING AVE**

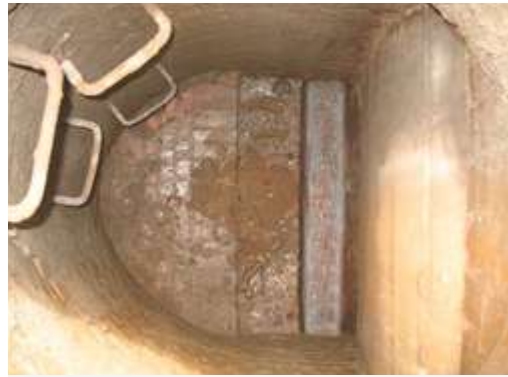
Top View

**Bench** ☒ Exists Material: **Brick** ☐ Parged ☒ **Debris** (not Condition related)  
Condition: ☒ Sound ☐ Cracked ☐ Root Intrusion ☐ Deteriorated ☐ Leaks ☐ Debris

**Steps** Count: **4** Missing: **0** ☒ **Corroded**

**Surcharge** ☒ **Evidence Of Surcharge** Depth: **1** (ft.) ☐ Active Surcharge Present

Corroded steps. Evidence of surcharge - Bench debris.

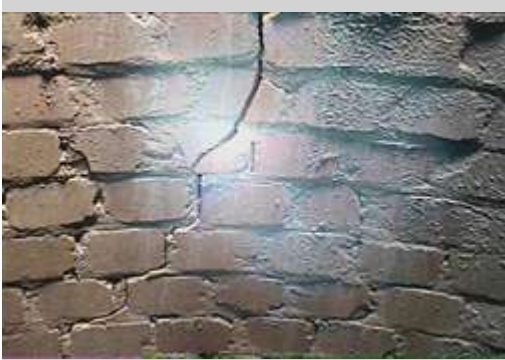
Defect

**Corbel** Material: **Brick** ☐ Parged Type: **Concentric/Eccentric**  
Condition: ☐ Sound ☒ **Cracked** ☐ Root Intrusion ☐ Loose Brick ☒ **Deteriorated**  
Infiltration: ☐ None ☐ Joint ☒ **Cracks** ☒ **Mortar** ☐ Roots ☒ **Wall**

**Barrel** Material: **Brick** ☐ Parged  
Shape: **D-Shape** Diameter: **42** (in.) Length: **38** (in.)  
Condition: ☐ Sound ☒ **Cracked** ☐ Root Intrusion ☐ Loose Brick ☒ **Deteriorated**  
Infiltration: ☐ None ☐ Joint ☒ **Cracks** ☒ **Mortar** ☐ Roots ☒ **Wall**

Corbel and Barrel deterioration, cracks and infiltration.

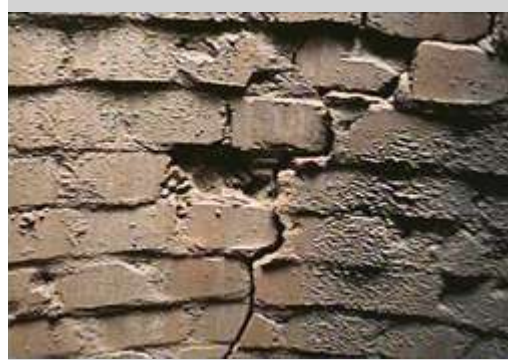
Defect

Corbel and Barrel deterioration, cracks and infiltration.

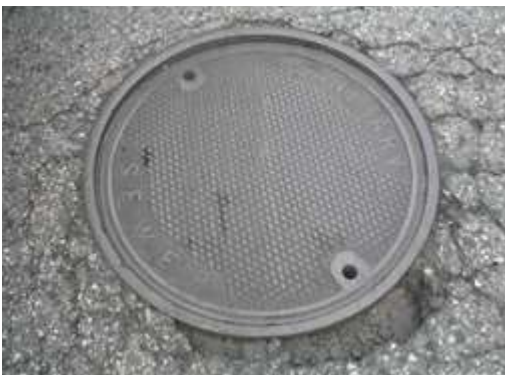
Defect

Deterioration around MH lid.

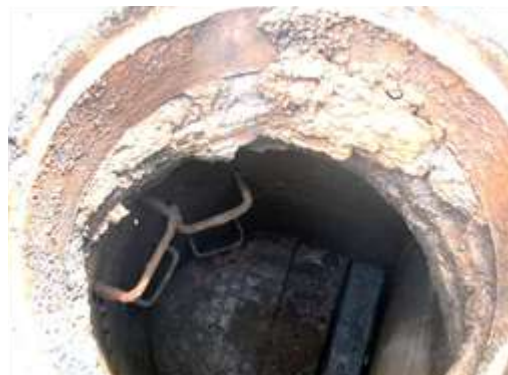
Defect

**Frame** Offset: **3** (in.) Condition: ☐ Sound ☐ Cracked ☒ **Leaks**

**Chimney / Frame Adjustment** ☒ Exists Material: **Brick** ☐ Parged Height: **12** (in.)  
Condition: ☐ Sound ☐ Cracked ☐ Root Intrusion ☐ Loose Brick ☒ **Deteriorated**  
Infiltration: ☐ None ☒ **Joint** ☐ Cracks ☐ Mortar ☐ Roots ☒ **Wall**

Frame leaks. Frame offset. Adjustment deterioration and infiltration. Barrel infiltration.

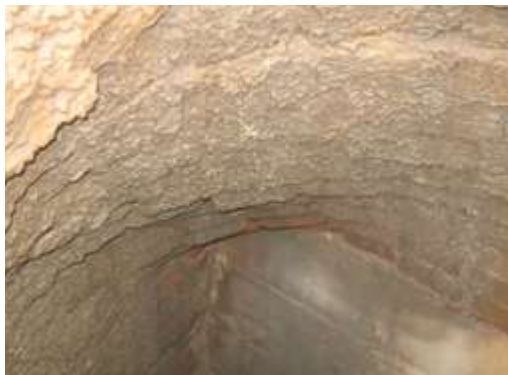
Defect

Barrel infiltration.

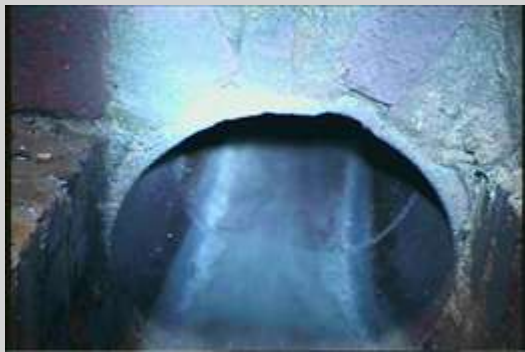
### 10 in. Circular Gravity Sewer Pipe Out @ 12 O'Clock

Deposits: ☐ None ☐ Mud ☐ Sludge ☐ Debris ☒ **Grease**

Silt Depth: **0** (in.) Deposits Extent: **Light**

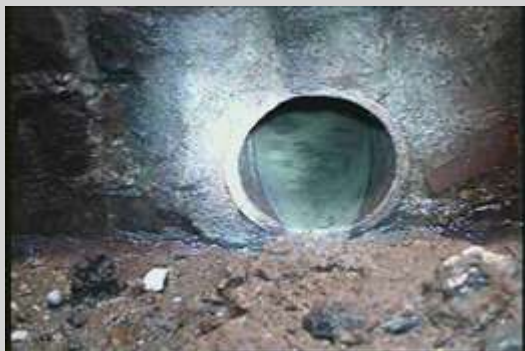
### 6 in. Circular Gravity Sewer Pipe In @ 3 O'Clock

Deposits: ☐ None ☒ **Mud** ☐ Sludge ☒ **Debris** ☐ **Grease**

Silt Depth: **1** (in.) Deposits Extent: **Light**

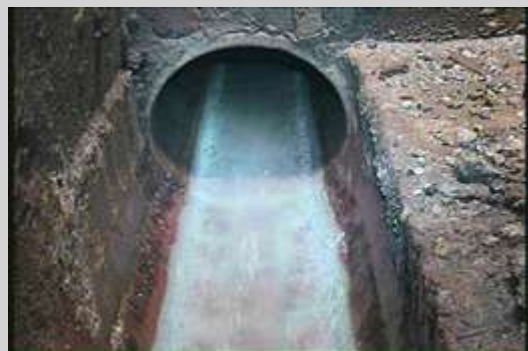
Pipe In @ 6 O'Clock

Deposits: ☐ None ☐ Mud ☐ Sludge ☐ Debris ☒ **Grease**

Deposits Extent: **Light**
